Manhole Inspection Summary

Manhole # S37GG_016MH

Insp Date: **3/23/07 12:40 PM**

Location Address: **1238 GREENMOUNT AVE**

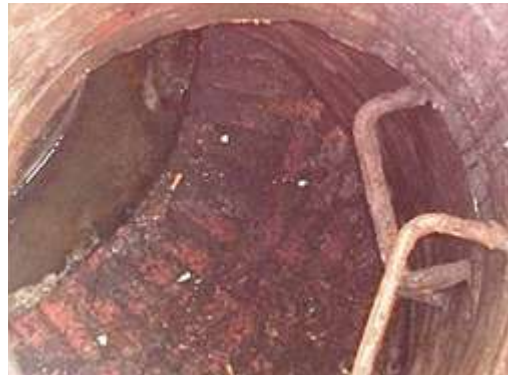
Top View

Corroded steps. Evidence of surcharge - Bench debris.

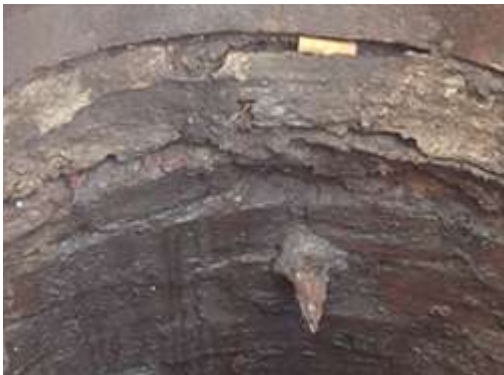
Defect

Frame leaks. Adjustment deterioration and infiltration.

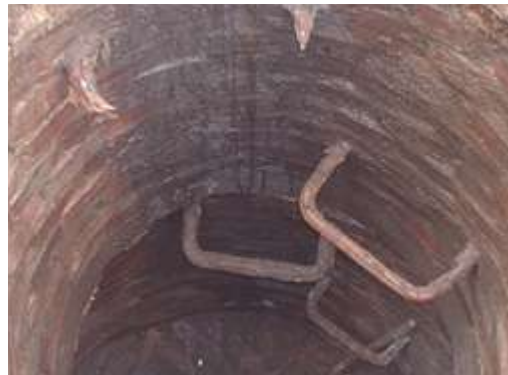
Defect

Barrel infiltraion. Corroded and missing steps.

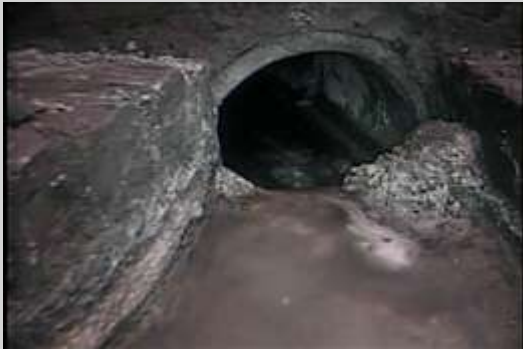
8 in. Circular Gravity Sewer Pipe Out @ 12 O'Clock

Deposits: ☐ None ☒ **Mud** ☐ Sludge ☒ **Debris** ☒ **Grease**

Silt Depth: **2** (in.) Deposits Extent: **Light**

Infiltration: **Evidence** Pipe Seal Cond: **Cracked**

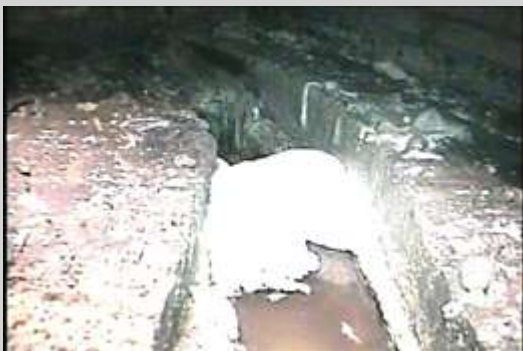
8 in. Circular Gravity Sewer Pipe In @ 6 O'Clock

Deposits: ☐ None ☐ Mud ☐ Sludge ☒ **Debris** ☒ **Grease**

Silt Depth: **3** (in.) Deposits Extent: **Medium**
